ENGINEERING ANALYSIS

RUSSIAN T34/85 TANK

SEPTEMBER, 1951

CIA Information Report Number 00-T-00061 THIS DOCUMENT CONTAINS INFORMATION AFFECTING THE NATIONAL DEFENSE OF THE UNITED STATES WITHIN THE MEANING OF THE ESPIONAGE LAWS, TITLE 18, U.S.C., SECTIONS 793 AND 794. THE TRANSMISSION OR THE REVELATION OF ITS CONTENTS IN ANY MANNER TO ANY UNAUTHORIZED PERSON IS PROHIBITED BY LAW.

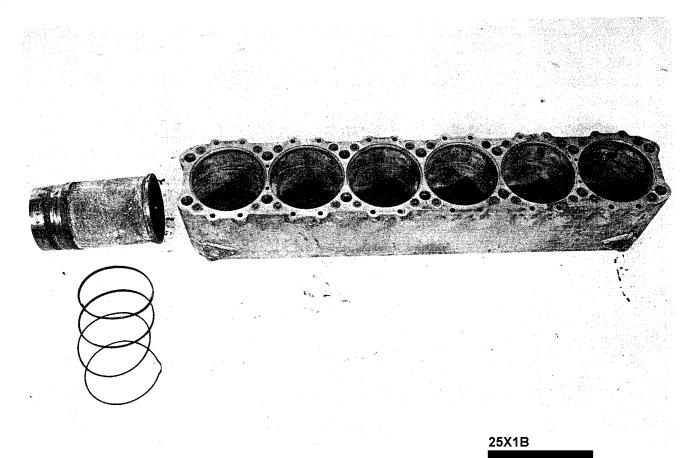
0101.1 c - CYLINDER BLOCK, TOP VIEW - ENGINE

Four cylinder liners removed from engine were gauged for uniformity of bore. Excellence of machining and freedom from wear are indicated by these measurements. The measurements are contained in the accompanying table. This table reveals only small variation due to taper and out-of-roundness in the liners checked. Taper of the top three inches, a possible measure of wear such as might have been accelerated by dust passing through the air cleaners, was very slight. None of the liners showed any appreciable scoring or other local wear. If the 741 km shown on the vehicle odometer was correct, it would be likely that very little dusty operation of the engine occurred.

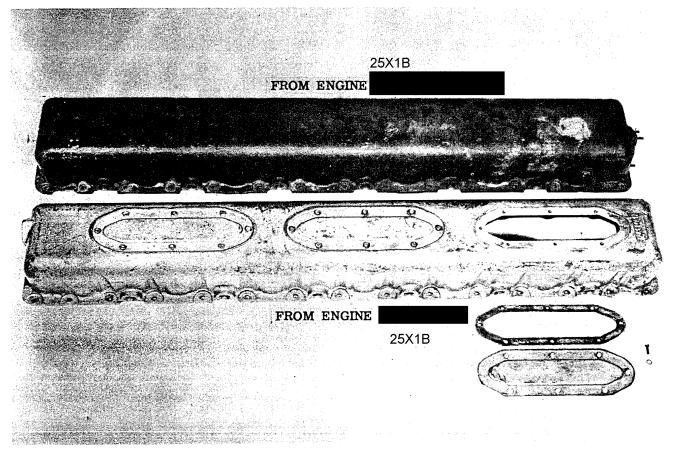
0101.3 - CYLINDER HEAD COVERS

Three different designs of cylinder head covers were found on the two G812 engines. All were cast iron in contrast to the aluminum castings used for other major engine parts. The covers on engine had no access plates for servicing of injector nozzles. The entire head cover had to be removed to do any servicing of the injector nozzles.

Both covers on engine had removable access plates. On one of these covers, the plates were steel stampings and on the other they were cast iron. It is probable that the head with steel plates is a replacement, since the other head was finished to match other iron castings on the engine.

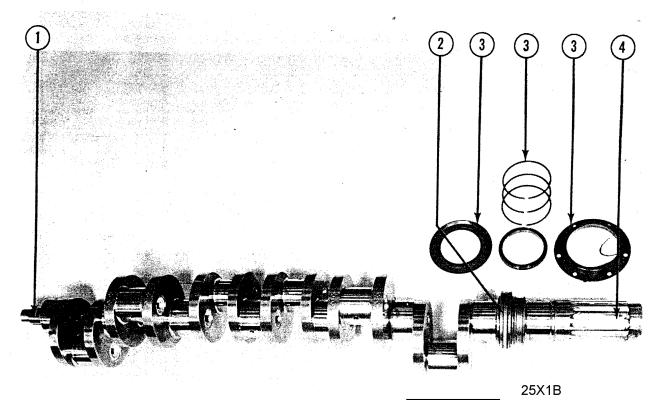
0102 - CRANKSHAFT - ENGINE

This crankshaft, machined all over, was found to have been forged rather than turned from a billet. Note the provision of the ball thrust bearing between the two rear main bearings. No difference was found between the two crankshafts from the two engines examined.

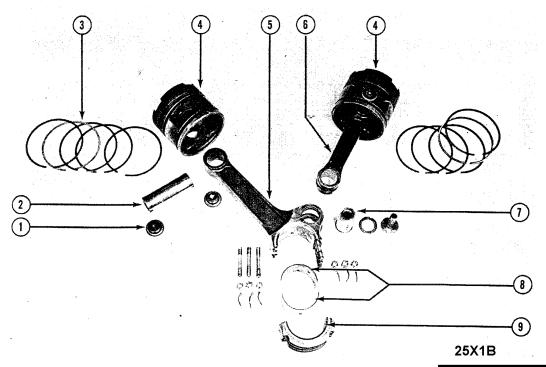
0104 - PISTON AND CONNECTING ROD ASSEMBLY - ENGINE

The auxiliary rod was pinned to the main rod by a hollow steel pin, which was pressed in and held in place by a large cap-type screw. This screw was locked to prevent loosening by a thin brass washer with a tab which was bent up into a notch in the screw head. Any tendency of the screw to loosen would not meet much resistance from the brass washer. Considering the tendency of the Russians to securely lock every nut and bolt that could possibly come loose, it is peculiar that they should depend upon this type of lock for such an important application as a connecting rod pin.

All parts in the assembly were well made and, judging from the number of inspection stamps, had been carefully inspected. It is apparent that the Russians had recognized the need for dependability of these parts and had made them with extreme care to provide that dependability. Pistons and bearings showed very little wear on either engine.

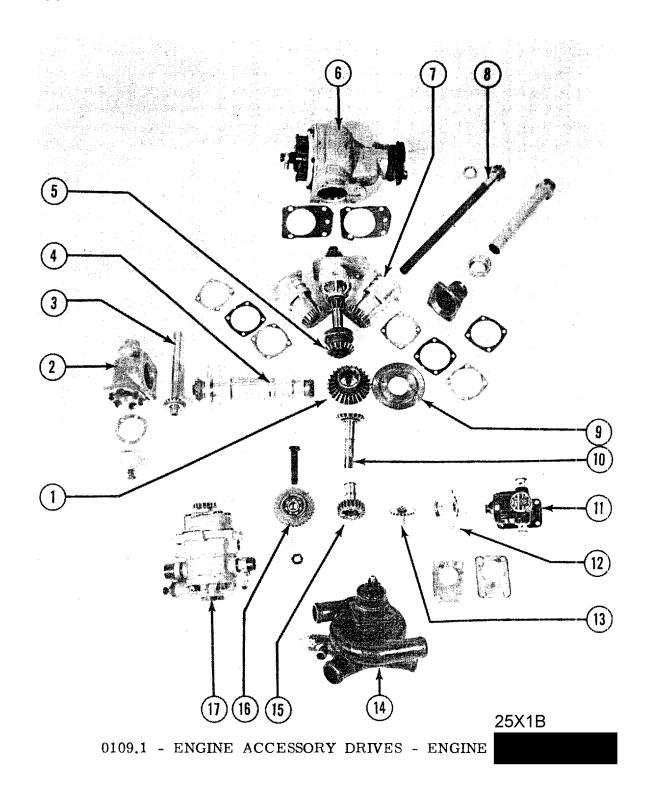
0109.1 - ENGINE ACCESSORY DRIVES - ENGINE

All gears checked were made of Krupp steel. No failures or signs of failures were noted on these gears on either engine examined. The life of the lower gears may have been greatly lengthened by the addition of the lubricating oil connection provided by the newer oil manifold described earlier. The fact remains, however, that the gears from the older engine, which was not provided with this extra oil connection, were also in excellent condition.

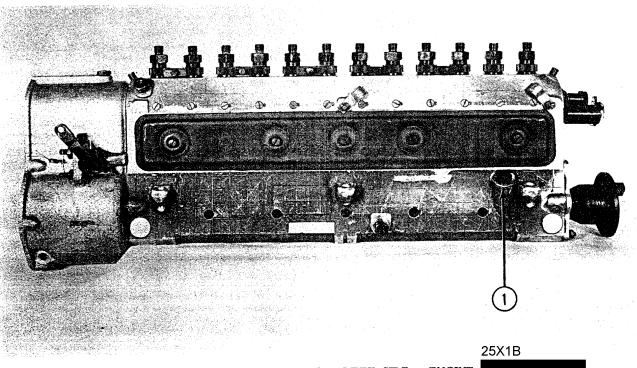
0301.1 c - FUEL INJECTOR PUMP - LEFT SIDE - ENGINE

The camshaft was supported by two ball bearings (one at each end) and five two-piece aluminum bearings uniformly spaced along the camshaft with two cam lobes between bearings. This is a more rigid support than is usual in U. S. practice. The tappet rollers had needle bearings. U. S. practice is to use a loose steel sleeve-type bearing between the tappet pin and the tappet rollers. A desirable feature found on this pump and not common on U.S. pumps is the provision in the design of the control sleeves to permit the removal of the plunger from the top of the pump. Fuel is fed into both ends of the pump to insure adequate supply to all cylinders. The rear fuel supply line is also connected to an air bleed Fuel leakage past the valve to remove air entrapped in the fuel system. nozzle valves and plungers is drained into the crankcase where it mixes with the engine lubrication oil. Lubrication of the pump after installation (before leakage provides fuel oil lubrication) is evidently provided by pouring a small amount of oil into the camshaft compartment. An oil level dipstick was provided on the pump to check for the presence of this oil before the engine was first started. Apparently, this dipstick was never used after the first oil supply was established. The dipstick location was not the same on the two G812 pumps (see photographs).

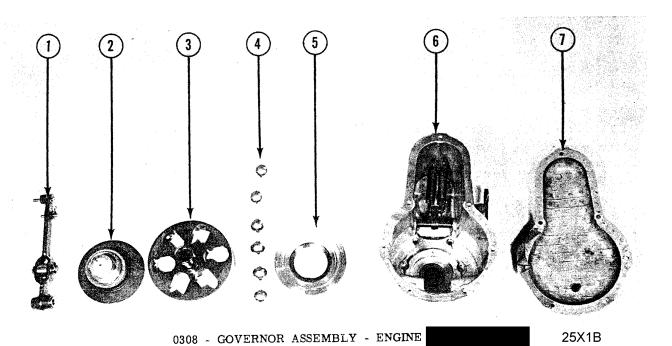
All interior parts were smoothly machined and in good condition. Wear on the pressure plates had occurred to a slight degree. A ball thrust bearing is used to transmit axial thrust and a needle bearing is used on the control arm. The governor case and cover plate were permanent mold. aluminum alloy castings.

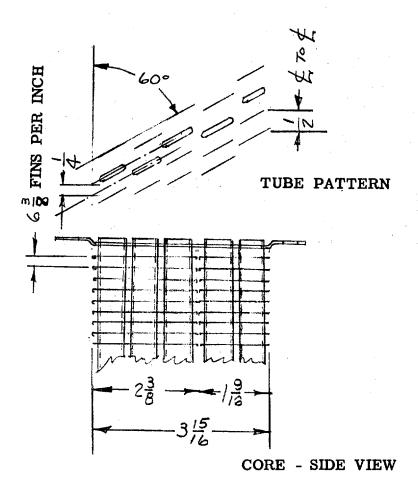
SECTION OF THE G812 RADIATOR CORE

The G812 tank demonstrated some possible causes of the poor cooling in the Aberdeen tank. Tube and fin construction of the radiators was very poor, particularly the soldering of the fins to the tubes. It was estimated that over 90% of the fins were non-functional, either for heat dissipation or core support because of the poor contact area of fins to tubes. There was no oil radiator in the Aberdeen tank, as there was in the G812. The addition of the oil radiator would help solve the cooling problem and may represent a change in design for that purpose. There was no way to tell if a change in the size of the fan had been made since the Aberdeen report, but the fan in the G812 tank may be bigger than that described in the German report (dimensions in the German report are too vague to be sure of a change).

Tubes were made of flattened seamless tubing with a wall thickness of .011", including solder coating. Tubes were located on 1/2" centerlines and 60° angle to core face. Cross-sectioned tubes measured approximately .665 x .145". The openings in the fins exceeded the .145" dimension by several thousandths throughout the core section. This condition resulted in only an occasional point of contact between the fins and tubes. As the result, over 90% of the entire fin area was non-functional, either for heat conduction and dissipation, or necessary core strength. The flanged openings were crudely formed as far as any intended fit to the tube contour. The dies used in forming the fins can be presumed to be very crude, particularly in regard to shape of punches.

The last tubes in each row were plugged with solder at the header. This condition can prevent failure of the tubes due to stress, these points being the most susceptible. However, it does not remedy tube to header solder joint failures. A tube to header solder joint failure was noted at the leading edge of one plugged tube at the end of the outside row. The .032" header thickness is very light for an assembly using bolted on tanks.

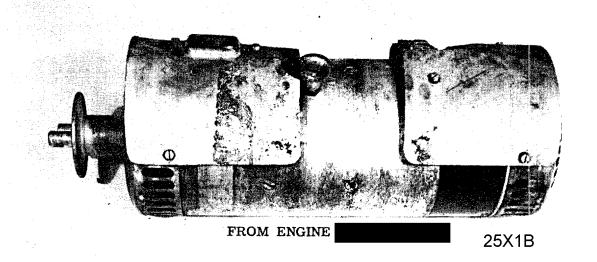
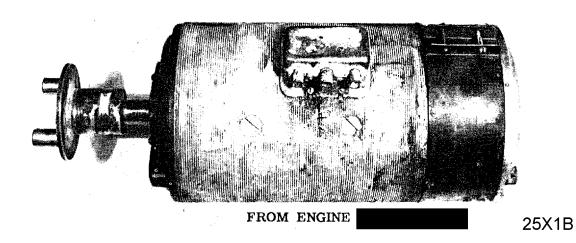
0601.3 - GENERATOR COMPARISON

Both generators - one from each of the two engines - were found to be totally enclosed. The generator from the '48 engine differed from the earlier model primarily in having three cooling fans. The earlier generator had none. This effort to increase generator capacity was understandable in view of the absence of any auxiliary power plant. Current capacity was not measured, but it was judged to be about 75 amperes for the fan-cooled model. This estimate agreed with the 75-0-75 range of the ammeter on the instrument panel.

Both generators were of conventional four brush design. The newer was found to have a greater number of armature poles and commutator segments, perhaps to minimize radio interference as well as to increase efficiency.

Both generators were found in excellent condition. The commutators, specifically, were smoothly finished and were unburned.

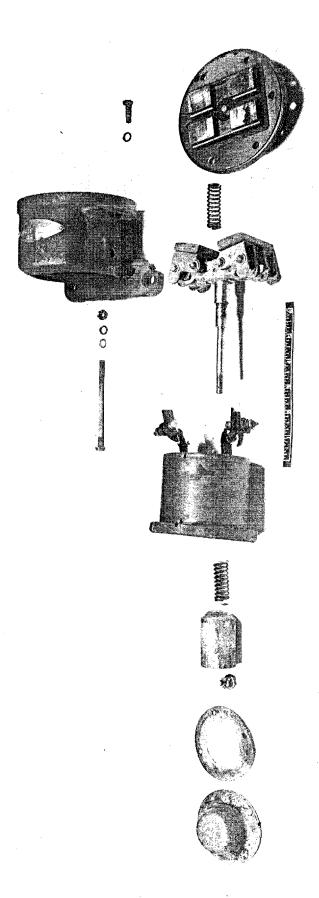
0603.2 a - STARTER RELAY

This relay appeared to be well made and seemed more than ample for its purpose. The contacts were unplated. Some burning had occurred, but the relay could still be expected to have an adequately long service life.

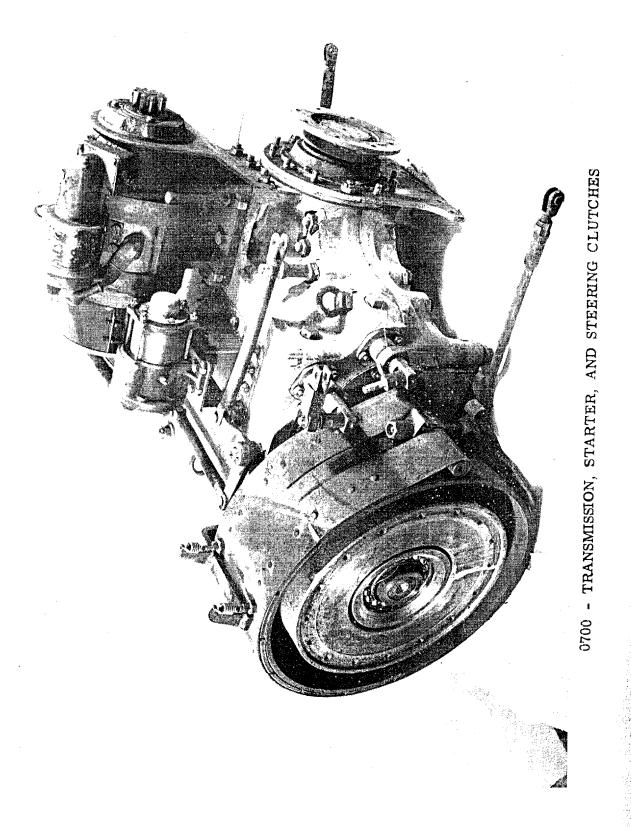
Gear wear was found to have been so severe that the transmission was regarded as having failed. Photographs in Appendix I show the extent of damage, probably very largely the result of clash-shifting made especially severe at a standing start because of high clutch drag in the multidisc dry clutch. The metal battered from the gear teeth was found in the bottom of the case. Analysis of the half cup of solid material removed showed an all-steel content - no sand or aluminum casting fins, as was first suspected.

In addition to battering at the ends of the teeth, there was extreme wear across tooth faces. This may have been a secondary result of battering of the edges, but might have occurred anyway, - especially in view of a similar though less severe wear of the final drive gears. It was judged to be a lubrication failure, one that could certainly have been postponed through the use of extreme pressure type of lubricant. No E.P. additives were found when the transmission oil was analyzed.

The face wear on the gear teeth was found to be tapered across the gear, giving the teeth a twisted appearance. This wear pattern may have been the result of the bending and twisting of the shafts carrying the gears. Twisting of the shafts under torsional load could be expected to cock the splines and therefore the gears, and excessive and tapered gear wear could then result for two reasons:

The most extreme wear had occurred on the 1st and 2nd speed and reverse gears, where the clash shifting damage could be expected to be most severe. Complete failure appeared imminent. If the 1st speed gears became unusable, reverse would be lost as well. All the other ratios were independent, however, and the stripping of one set would not affect the others (except that steel fragments could jam in and hasten the destruction of the other gears). In any case, the transmission appeared to be a weak link in the T34 tank.

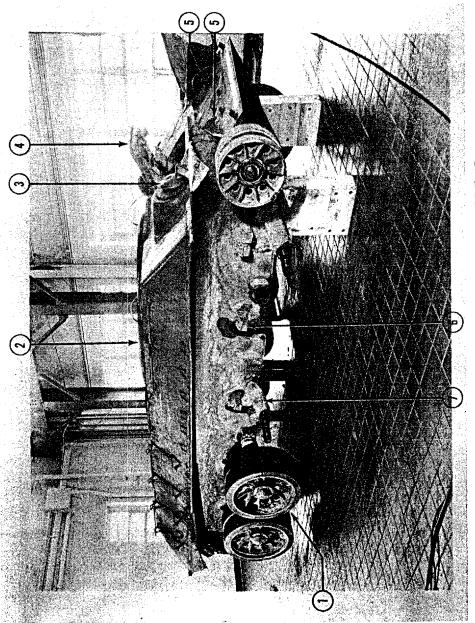
1800 b - HULL, PARTIALLY STRIPPED

A circular plate, directly below the main clutch assembly, had been cut from the hull bottom and then welded back in place. Reason unknown.

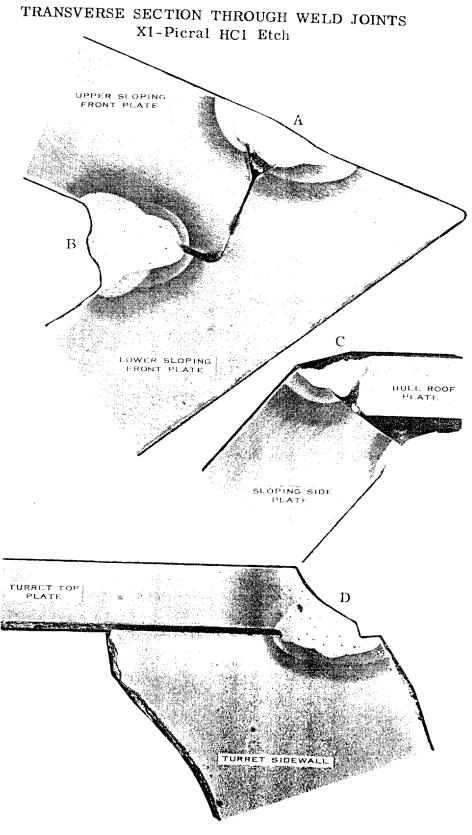
Figure 1

Figure 1. Bow joint between upper and lower sloping rolled homogeneous armor hull front plates, with the top plate resting in a groove cut into the lower plate. Outer and inner welds made with submerged arc process using ferritic electrodes.

Multi-pass weld composed of at least three beads. Top pass is automatic submerged arc. Underneath passes are also thought to be submerged arc as indicated by good penetration. Slag pockets present with intergranular cracking extending toward surface. Penetration and fusion is satisfactory as it was with other multipass welds. Hardness traverse across the weld interface showed variations in hardness from R"C" 18 in the weld metal, from R"C" 36 to R"C" 43 in the portion of heat affected zone that exceeded the critical, and from R"C" 30 to R"C" 44 in the area where the heat affected zone blends into the unaffected armor. No use was made of annealing bead technique.

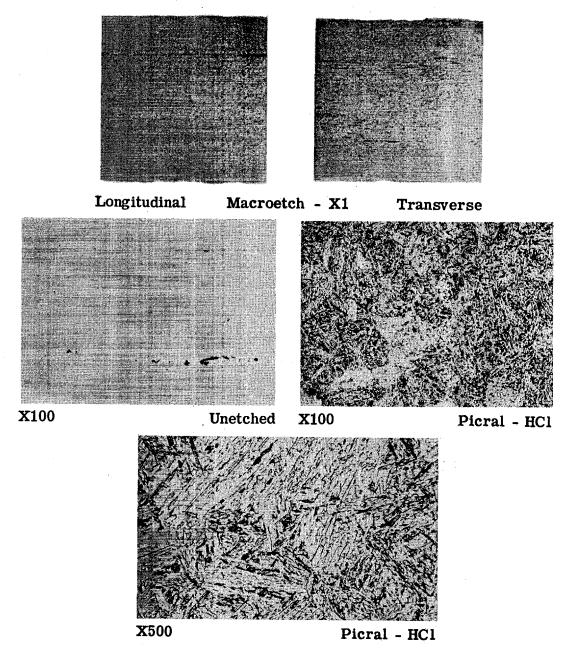
Figure 6
Macrostructure and Microstructure

Upper Sloping Front Plate

A moderately clean steel with typical inclusions shown in the photomicrograph. This material was completely martensitic from surface to center, indicating good solution and good quench. The material possibly had a low temper. Rolling appears to be in one direction only.

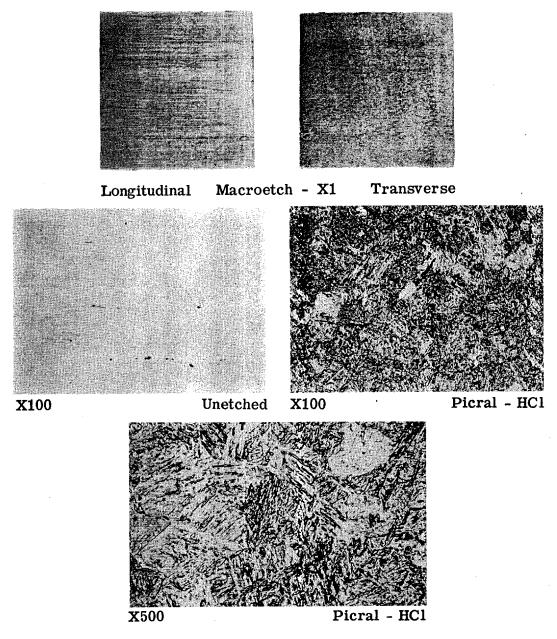
Figure 7

This armor was found to be very clean. Typical well scattered inclusions are shown in the unetched photomicrograph. Examination of the structure from the surface to the center showed it to be all martensite with a possible low temper, thus indicating good solution and a good quench. Rolling is in one direction only.

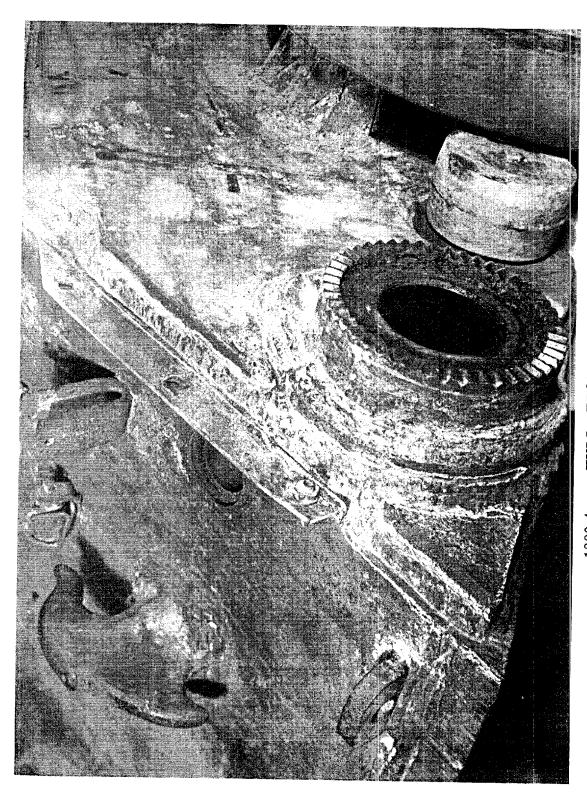
1800.4 a - HULL, FRONT LEFT VIEW

Weld joining the idler wheel arm housing to the hull side plate: (See photograph 1800.4a)

The idler wheel arm housings were manually welded on the hull side plates prior to the fabrication of the side plate and hull. Ferritic welding electrode was used. The side plate to top sloping front plate welds were made using stainless steel electrodes.

The welding was done as the plates would stand in their normal position. The welds were made on the flame-cut surfaces, without cleaning. The very bumpy weld beads are manual deposits and suggest a low order of operator skill.

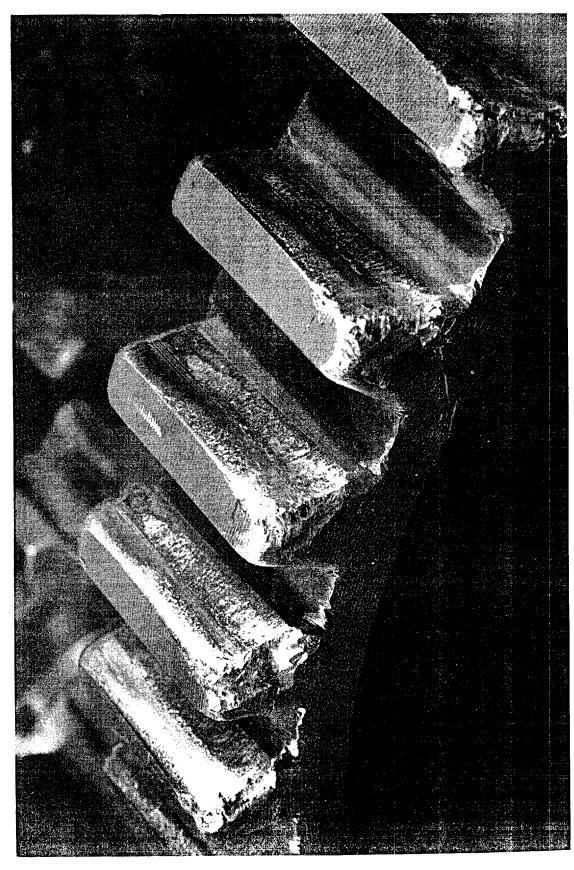
0702.3.1 a - FTRST SPEED DRIVEN GEAR

The first speed gear was forged, machined, carburized all over and hardened except for the bore. The gear was then shot blasted and the top of the splines on the inside of the hub rough ground. The ends of the hub were faced. Both engaging ends of the teeth were battered and chipped. There appeared to be inadequate chamfer. The teeth were heavily worn on opposite ends on both sides. Photograph 0702.3.1 a

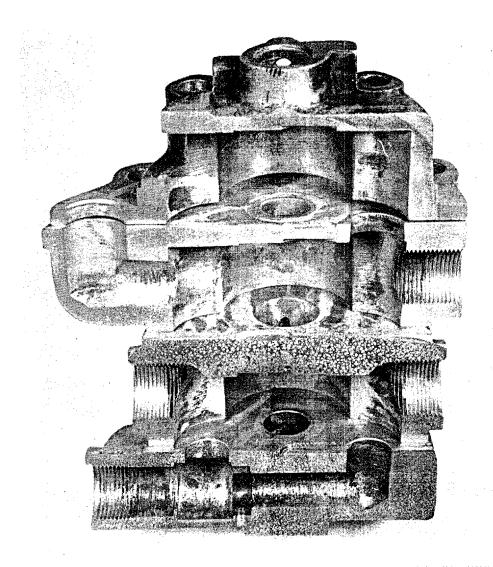
6404 - MACRO SECTION OF OIL PUMP BODY - T34 ENGINE

D. Manufacturing Method & Quality Permanent mold casting - Good quality - B.H.N. value indicates heat treatment - Sol'n. tr. and aged.	
	<u> </u>

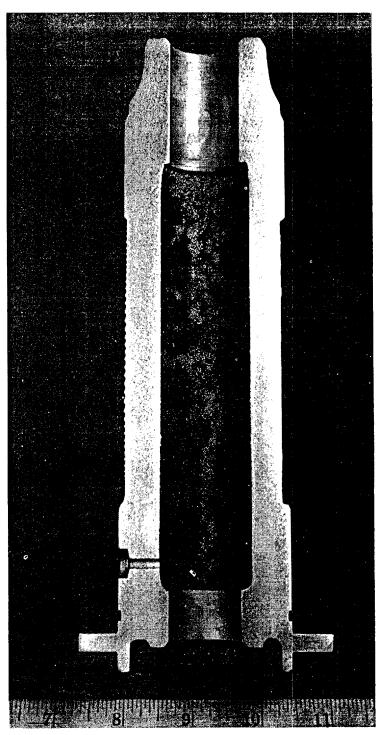
6405 - MACRO SECTION OF CAMSHAFT DRIVE PINION BEARING SUPPORT - T34 ENGINE

B. Machining Finish ground surfaces (40-50 micro inches on flanges and bearing areas.
C. Design Quality Ribs poorly blended to body - Wall sections heavily scribed good practice.

D. Manufacturing Method & Quality Semi-permanent mold cast-Good quality of metal - BHN value indicated Sol'n tr. and aged condition.
MICROSTRUCTURE: Aluminum silicide present in medium to coarse form in matrix.

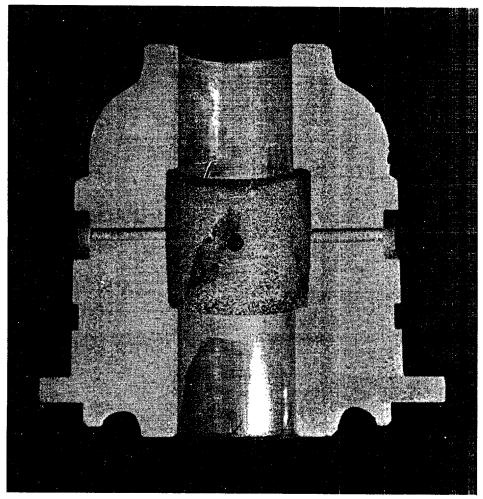
B. Machining Ground surfaces on flanges and bearing areas 25-35 micro inches.
C. Design Quality Grossness in design - poor blending of rib
D. Manufacturing Method & Quality Semi-permanent mold - Heavily scribed surfaces - Good quality of metal - BHN indicates solution heat treatment and aging.
MICROSTRUCTURE: Aluminum silicide in medium form dispersed thru matrix. Good normal structure.

6406 - MACRO SECTION OF ACCESSORY DRIVE SHAFT BEARING

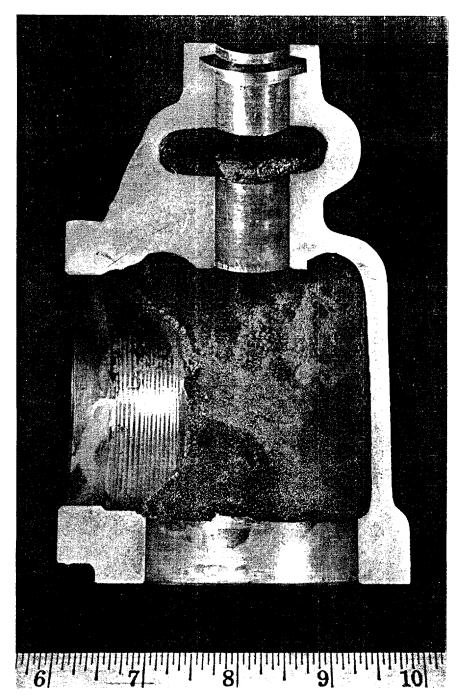
Part Name	Generator	Coupling Driv	e Shaft Center Bearing
_		062000	
Laboratory S	erial No.	203099	_Date
X-RAY EXA	MINATION	i: XCED	NO. H-146 - Revealed shrink at
junction of h	eavy flang	ge to thin wal	l section of body. Some blows as gas
holes and por	osity - Fa	ir quality.	
MACRO EXA		N: Photograp	h 6407, showed a uniform fine grain size -
		~. 0 	. / 6d To 50d Mo 08d Ma 20d
CHEMICAL	ANALYSIS	. Si 8.7%, C '.5%, Ti <u>/</u> .05%	tu /.6%, Fe .52%, Mn .28%, Mg .30%,
			25X1A
Compares to	ALCOA	356 alloy	
HARDNESS V	/ALUE:	93 B.H.N.	Weight of1.42Pounds
Finish Clea	nup normal	- Some evide	nce of tool marks and burned core sand.
COMMENTS:	line. Ro	ough interior	surfaces due to sand core erosion.
(hining Groun	d surfaces on bearing and flanged areas -
25-60 micro i	nches.		
and the second s		A Company of the Comp	Gross design in flange areas - Good blend-
ing of section	115 •

- 4		······································	
	D. Mar	ufacturing M	ethod & Quality Semi-permanent mold
casting - Goo	d quality	of cast metal	- Scribed mold - BHN value indicates
sol'n treat a	nd aged ca	asting.	
MICROSTRU	CTURE: 1	Medium form of	aluminum silicide constituent dispersed
uniformly in	o - 0,1\	Normal structu	
<u> </u>

6407 - MACRO SECTION OF GENERATOR DRIVE SHAFT CENTER BEARING

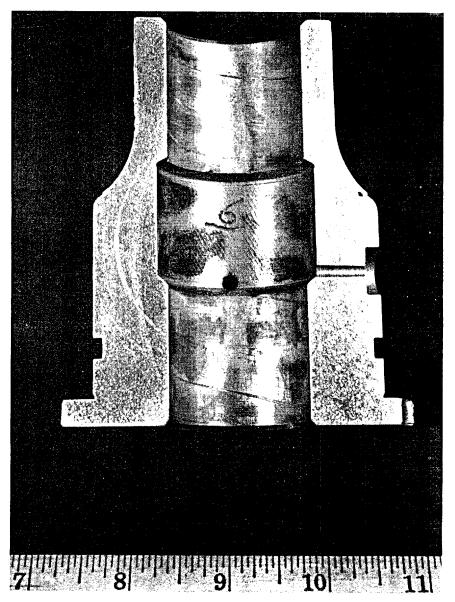
Part Name Lower Camshaft Drive Gear Bearing
Laboratory Serial No. 263102 Date
X-RAY EXAMINATION: XCED NO. H-149 Revealed a sound structure, no porosity or shrinkage detected. Good quality.
MACRO EXAMINATION: Photograph 6409, showed a uniform fine grain structure - Good quality.
CHEMICAL ANALYSIS: S1 8.3%, Cu /.6%, Fe .52%, Mn .20%, Mg .30%, Ni /.5%, Cr /.04%, Zn /.5%, Ti /.05%, Zr /.05%
Compares to Alcoa 356 alloy 25X1A
HARDNESS VALUE: 100 B.H.N. Weight of 1.80 Pounds Finish Satisfactory cleanup - Tendency to leave more stock than normal machining allowance needs. COMMENTS: A. Workmanship Heavy parting lines indicate mold not completely closed. B. Machining Finish ground to 22-25 micro inches on all
bushing and flange surfaces.

C. Design Quality Satisfactory - Good blending of sections - Could reduce section thickness.
D. Manufacturing Method & Quality Semi-permanent mold casting. Good quality casting - Scribed mold walls - B.H.N. value indicates solution treatment and age to Alcoa T6 condition.
MICROSTRUCTURE: Medium form of the usual aluminum silicide dispersed niformly thru matrix. Normal structure.

6409 - LOWER CAMSHAFT DRIVE GEAR BEARING - T34 ENGINE

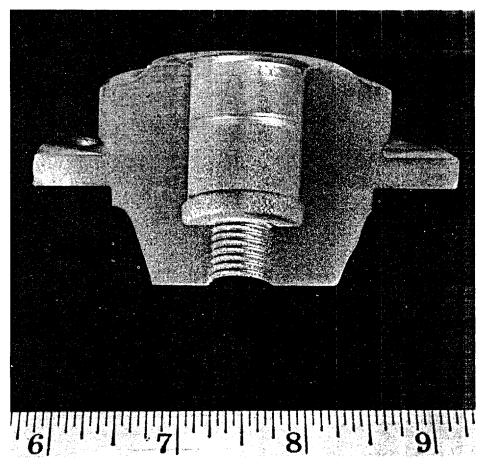
Part Name Generator Coupling Drive Shaft End Bearings
Laboratory Serial No. 263103 Date
X-RAY EXAMINATION: XCED NO. H-150 Revealed a very sound dense structure - No shrink - No porosity - Good quality.
MACRO EXAMINATION: Photograph 6408, showed a fine uniform grain structure - Good metal quality.
CHEMICAL ANALYSIS: Si 9.2%, Cu /.6%, Fe .60%, Mn .25%, Mg .30%, Ni /.5%, Cr /.04%, Zn /.5%, Ti /.05%, Zr /.05%
Compares to Alcoa 356 alloy 25X1A
HARDNESS VALUE: 100 B.H.N. Weight of 0.44 Pounds Finish Satisfactory - little cleanup noted.
COMMENTS: A. Workmanship Mold appeared in good condition - workmanship satisfactory.

B. Machining Finish ground surfaces 45 to 50 micro inches on bearing areas - Stock left for machining allowances more than necessary.
C. Design Quality_Satisfactory - Although heavy sections
could be reduced and ribbed for strength.

D. Manufacturing Method & Quality Permanent mold casting - Flange areas of mold scribed - B.H.N. indicates solution treatment and aged to Alcoa T6 condition.
MICROSTRUCTURE: Medium form of aluminum silicide present, in matrix - formal structure - Also evidence of aluminum iron - silicide constituent in cicular form.

6408 - MACRO SECTION OF GENERATOR COUPLING DRIVE SHAFT END BEARING - T34 TANK ENGINE

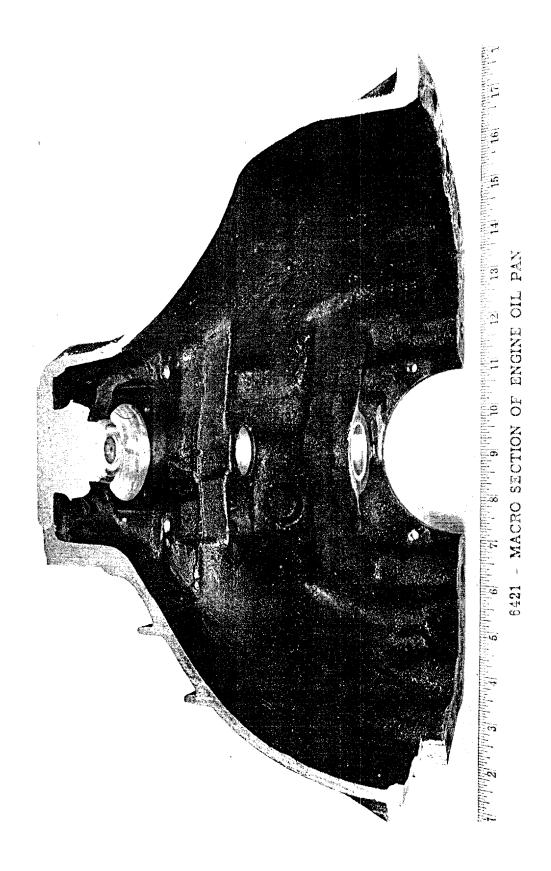
321 -

Part Name Oil Pan (Lower Crankcase)
Laboratory Serial No. 263163 Date
X-RAY EXAMINATION: XCED NO. H-160 Revealed a good sound
structure, little to no shrink or porosity in this large casting - Good
quality.
MACRO EXAMINATION: Photograph 6421, showed a medium to fine uniform
grain structure, some pinhole porosity - Good quality casting.
CHEMICAL ANALYSIS: Si 8.7%, Cu Tr., Fe.l-1%, Mn .l-1%, Mg .l-1%, Ni \(\frac{1}{5}\), Zn \(\frac{1}{5}\), Ti \(\frac{1}{1}\), Cr Nil, Zr Nil
Compares to Alcoa 356 alloy 25X1A
HARDNESS VALUE: B.H.N. 70 Weight of 54.0 Pounds Finish Normal cleanup - slight core shift - Used phthalate type of coating on interior and exterior. COMMENTS: A. Workmanship Some erosion - Some incomplete coring - rough finish possibly due to soft ramming.

B. Machining Finish machined flange faces to 100-110 micro inches. Machining allowances greater than needed.
C. Design Quality Satisfactory filleting and blending. Rib design poor-used a rounded rib design - Heavier section thickness in rib would be advisable.

D. Manufacturing Method & Quality Sand casting - Good quality - B.H.N. reveals part was in the as-cast condition.
MICROSTRUCTURE: Simple structure showing aluminum silicide dispersed thru matrix.

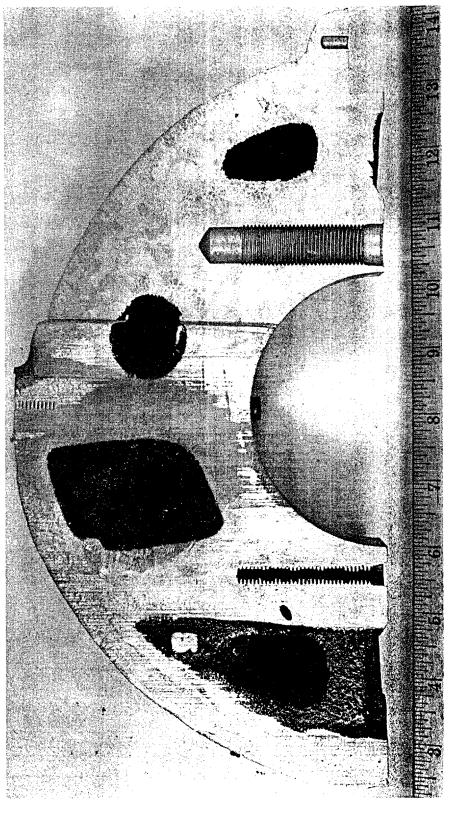
Part Name Engine Crankcase (Upper)
Laboratory Serial No. 263164 Date
X-RAY EXAMINATION: XCED NO. H-161
Little to no shrink or porosity as normally detected by radiographic inspec-
tion - Good quality.
•
MACRO EXAMINATION: Macro inspection, photograph 6422, showed very
large gross grain structure indicative of a slow cooling process during
casting. Shrinkage evident in dendritic pattern.
CHEMICAL ANALYSIS: Si 10.7% Cu tr Fe .1-1% Mn .1-1% Mg .1-1% Ni /.5% Zn /.5% Ti /.1% Cr Nil Zr Nil
Compares to Alcoa 356 alloy 25X1A
HARDNESS VALUE: BHN 93 Weight of 59 Pounds Finish Poor cleanup on casting - Foreign inclusion in form of sand - some
plate formed. COMMENTS: A. Workmanship Satisfactory - Good sand coring practice. Slight washes.

B. Machining Satisfactory - Flanges machined to 100-169 micro inches. Sleeve insert surfaces ground to 25 to 30 micro inches.
C. Design Quality Satisfactory design - Good radii blending practiced. Boss areas slightly gross.

D. Manufacturing Method & Quality Semi-permanent mold casting - Good quality. BHN value indicates part was sol'n treated and aged
to the Alcoa T6 condition. Molds scribed to improve casting.
MICROSTRUCTURE: Silumin alloy - Aluminum silicide constituent dispersed thru aluminum matrix.

6422 - MACRO SECTION OF ENGINE CRANKCASE

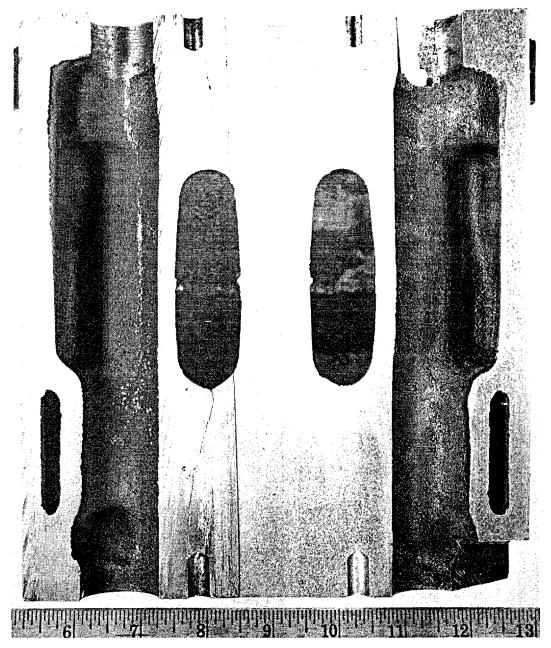
Part Name Engine Cylinder Block
Laboratory Serial No. 263165 Date
X-RAY EXAMINATION: XCED NO. H-162 Numerous blows in form of gas and porosity - One crack between #1 and #2 cylinders thru sound metal
section - Good quality.
MACRO EXAMINATION: Macro inspection, photograph 6424, shows a fine uniform grain size - Metal quality good.
CHEMICAL ANALYSIS: Si 8.7%, Cu tr, Fe .1-1%, Mn .1-1%, Mg .1-1% Ni / .5%, Zn / .5%, Ti / .1%, Cr Nil, Zr Nil
Compares to Alcoa 356 alloy 25X1A
HARDNESS VALUE: BHN 93 Weight of 59 Pounds Finish Poor cleanup on casting - Foreign inclusion in form of sand - Some plate formed. COMMENTS: A. Workmanship Satisfactory - Good sand coring practice. Slight washes.

D. Manufacturing Method & Quality Semi-permanent mold casting - Good quality. BHN value indicates part was sol'n treated and aged to Alcoa T6 condition. Molds scribed to improve casting.
MICROSTRUCTURE: Silumin alloy - aluminum silicide constituent dispersed thru aluminum matrix.

6424 - MACRO SECTION OF ENGINE CYLINDER BLOCK

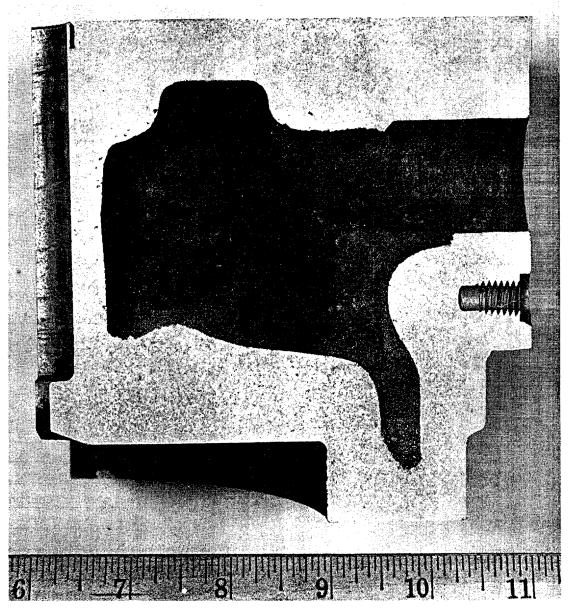
Part Name Engine Cylinder Head
Laboratory Serial No. 263166 Date
X-RAY EXAMINATION: XCED NO. H-163 Medium porosity noted in coolant passages - Core wire noted in coolant passages. Good quality.
MACRO EXAMINATION: Macro inspection, photograph 6423, showed uniform fine grain structure with some blows near sand cored areas in form of porosity and gas holes. Good quality of metal.
CHEMICAL ANALYSIS: Si 8.2%, Cu Tr Fe .1-1%, Mg .1-1%, Ni 2.5%, Zn 2.5%, Ti 2.1%, Cr Nil, Zr Nil Compares to Alcoa 356 alloy
HARDNESS VALUE: 80 BHN Weight of 82.5 Pounds Finish Cleanup did not appear to be excessive. Some inclusions in cored passages - Core wire. COMMENTS: A. Workmanship Satisfactory. Rough interior surfaces possibly attributed to poor sand core handling or preparation. B. Machining Satisfactory - Surfaces finished to 50-56
micro inches - Good machining allowances.

C. Design Quality Some tendency towards grossness in design - good filleting - blending practiced.
D. Manufacturing Method & Quality Semi-permanent mold casting - Good quality - BHN value indicates part had been stabilized for operating conditions to Alcoa T6 condition.
MICROSTRUCTURE: Simple silumin structure containing aluminum- silicide constituent uniformly dispersed thru aluminum matrix.

6423 - MACRO SECTION OF ENGINE CYLINDER HEAD

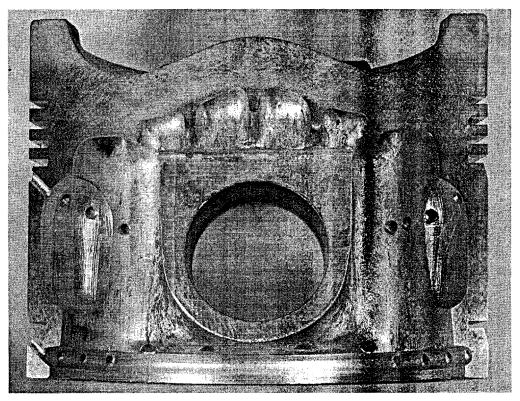
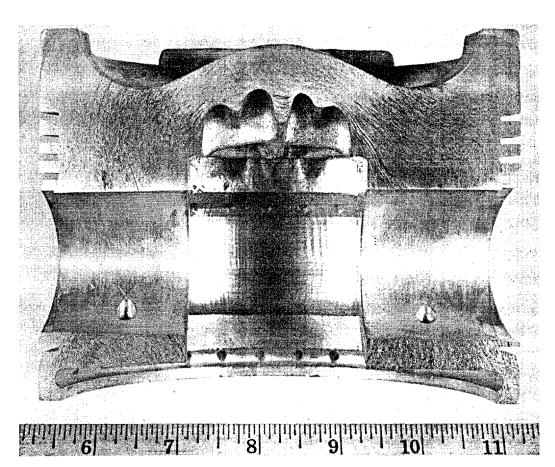
Part Name Engine Piston
Laboratory Serial No. 262087 Date
X-RAY EXAMINATION: XCED NO. H-092 No defects noted during
radiographic inspection. Very sound dense structure - Good quality.
MACRO EXAMINATION: Dy-Check showed forging seam which formed seam extending 1/2" into piston head. Macro, photographs 6384A-B, lack of uniform
metal flow in forged part. Quality fair.
CHEMICAL ANALYSIS: Fe 1.50%, Cu 2.6%, Ni 2.7%, Mg 2.2%, Mn .17%, Zn Nil, Si .87%, Al Bal. Compares to
HARDNESS VALUE: See attached sheet Weight of 5.26 Pounds Finish No electro plated or chemical finishes. Machining allowances satisfactory. COMMENTS: A. Workmanship Wall section on one side where balancing was performed showed 1/2" reduction in wall thickness over opposite side.

B. Machining Machined and ground surfaces on piston skirt 120 micro inches; pin hole 50-55 micro inches; polished head 30 micro inches.
C. Design Quality Truck type piston - Not cam ground - Adequate oil return holes - Heavy crown head - Good fillets. Back of head reinforced with ribs for conductivity and strength.

D. Manufacturing Method & Quality Forging - Satisfactory or fair quality. B.H.N. indicates Alcoa T6 condition - Solution heat treat and aged. Engine temperatures reduced hardness in crown of piston as shown in accompanying sketch.
MICROSTRUCTURE: Copper - aluminum - iron constituent at grain bound-
aries near coarse nickel - aluminum constituent uniformly dispersed thru
forged structure. High nickel gives hot strength to alloy.

6384 A - MACRO SECTION OF PISTON

6384 B - MACRO SECTION OF PISTON

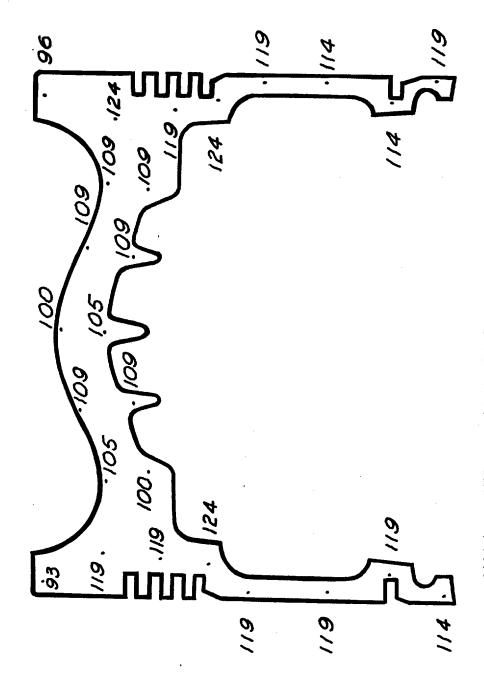
0104.1 - BRINELL HARDNESSES OF PISTON CROSS SECTION

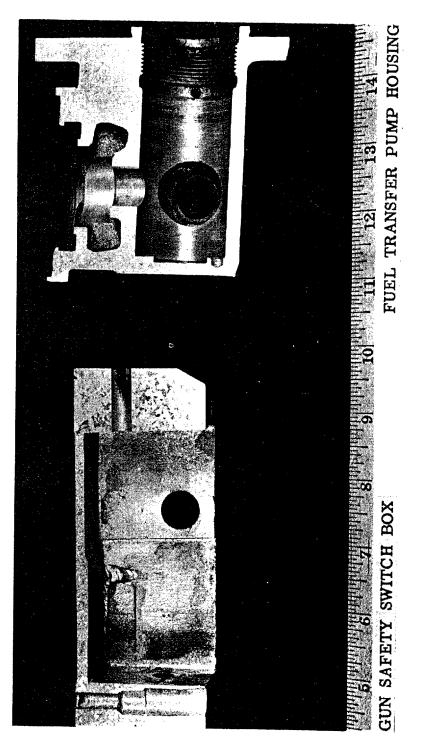
Part Name Gun Safety Switch Box	
Laboratory Serial No. 263837 Date	
X-RAY EXAMINATION: XCED NO. H-250 Revealed a sound cas	t
ing free of defects normally detected by radiographic inspection. Good	
quality.	
MACRO EXAMINATION: Photograph 6443, showed fine to medium grain structure. Good metal quality.	
CHEMICAL ANALYSIS: Cu 5.7%, Si 1.6%, Fe 1.3%, Mn .53%, Mg .20%, Ni \(\sigma .20\)%, Zn \(\sigma .50\)%, Al Bal	
Compares to Alcoa 195 alloy.	
HARDNESS VALUE: B.H.N. 105Weight of1.10Pour Finish Normal cleanup - Painted green (dark) COMMENTS: A. Workmanship Satisfactory - No defects noted.	nds

B. Machining Satisfactory - Hole deformed during drilling operations. Too much reduction in wall section in several holes.	g
C. Design Quality Good attention to fillets - wall sect too thin in some areas.	ion

D. Manufacturing Method & Quality Permanent mold cast - Good quality. B.H.N. value indicates part was heat treated to Alcoa T6	ings
condition (Sol'n Treat and age)	
MICROSTRUCTURE: Copper - Aluminum and Cu-Fe-Mn-Al constituents - Pl brittle phase in which numerous fine cracks were noted and oxide inclusion

6443 - MACRO SECTIONS OF T34 COMPONENTS

Part Name Fuel Transfer Pump Body
Laboratory Serial No. 263835 Date
X-RAY EXAMINATION: XCED NO. H-251 Revealed some micro shrinkage radiating from hole, also some porosity (slight) in body section -
Good quality.
MACRO EXAMINATION: Photograph 6443, shows a uniform medium grain size to fine grain size. Very good metal quality.
CHEMICAL ANALYSIS: Cu 2.15%, Si 4.9%, Fe .65%, Mn .50%, Mg /.10%, Ni /.20%, Zn /.50%, Al Bal.
Compares to Alcoa 195 alloy
HARDNESS VALUE: B.H.N. 76 Weight of 1.10 Pounds Finish Normal cleanup - No tool marks - Very good condition - Suspect chromate chemical treatment used as a protective coating on interior and exterior of part. A. Workmanship Good workmanship - Good coring of internal passages. Good cleanup - No inclusions.

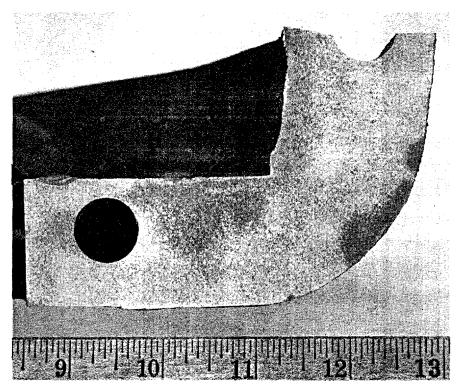
Part Name Upper Transmission Case
Laboratory Serial No. 263162 Date
X-RAY EXAMINATION: XCED NO. H-159 Scattered porosity and
some gas holes noted in casting. Porosity near junction of heavy to thin
sections - Good quality.
MACRO EXAMINATION: Macro inspection, photograph 6420, showed a uniform fine grain structure. Good metal quality.
CHEMICAL ANALYSIS: Cu 3.5%, Zn 13.3%, Si tr, Fe tr, Mg /.1%, Mn Nil, Al Bal.
Compares to Alcoa 645 alloy
HARDNESS VALUE: BHN 74 Weight of 118.5 Pounds Finish Poor cleanup - Gates knocked off with hammer. Tool marks noted - some
sand inclusions. COMMENTS: A. Workmanship Fair to good in vital areas - part showed some evidence of poor sand molding.

B. Machining Ground finish to 40-50 micro inches in bearing areas. Adequate machining allowances.
C. Design Quality Satisfactory - Good blending - filleting Grossness in wall thickness and bosses noted.

D. Manufacturing Method & Quality Sand Casting - Good quality. As-cast condition - Heat treatment of this high zinc alloy would result in hot shortness.
MICROSTRUCTURE: Simple structure showing Copper-Aluminum constituent a grain boundaries - Zinc is in solid solution and not visible.

6420 - MACRO SECTION OF TRANSMISSION CASE

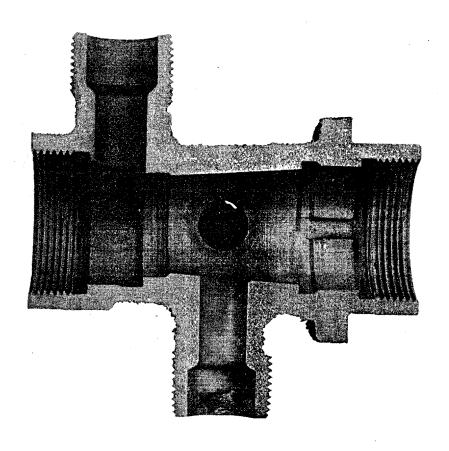
Part Name Fuel Tank Selector Valve (For Air Pressurization)
Laboratory Serial No. 263839 Date
X-RAY EXAMINATION: XCED NO. H-257 Revealed a sound casting
of very good quality.
MACRO EXAMINATION: Macro inspection, photograph 6442, showed a very fine uniform grain structure - Quality of metal good.
CHEMICAL ANALYSIS: Al 4.7%, Cu 1.4%, Fe \(\05\%, Mg \) .007\%, Sn \(\005\%, Cd .008\%, Zn \) Bal
Compares to Zamak 5
HARDNESS VALUE: Weight of .88 Pounds
Finish Satisfactory - normal cleanup - no chemical or electroplated coatings used on part. COMMENTS: A. Workmanship Satisfactory - Mold operation evidently good.

B. Machining Satisfactory, however, excessive machining allowances were used.
C. Design Quality Satisfactory - proper blending radii used. Section thickness adequate.

D. Manufacturing Method & Quality Sand Casting - Fair quality - as-cast condition. Normally sand castings from this allow are confined solely to experimental work.
MICROSTRUCTURE: Structure - white particles of solid solution of copper and aluminum in zinc - in matrix of eutectic formed by zinc rich and aluminum rich solid solution phases.

6432 - MACRO SECTION OF FUEL TANK SELECTOR VALVE BODY

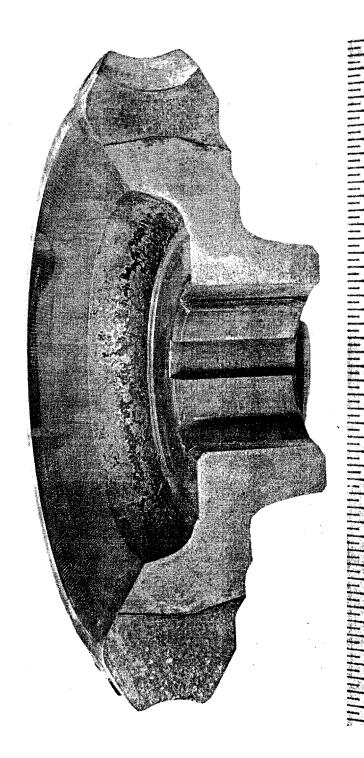
Part Name Worm Wheel - Turret Drive
Laboratory Serial No. 264058 Date
X-RAY EXAMINATION: XCED NO. H-281 Revealed a sound struc-
ture with some space due to contraction between steel hub and bronze worm
gear - Good quality.
MACRO EXAMINATION: Macro inspection, photograph 6444, showed a medium to fine grain size. Quality of metal was good.
CHEMICAL ANALYSIS: Cu 89.7%, Fe 2.9%, Al 7.5%, Si 0.10%
Compares to ASTM B-148-41T
HARDNESS VALUE: Rockwell "B" 74 Weight of Pounds
Finish Satisfactory finishing
COMMENTS: A. Workmanship Satisfactory

B. Machining Very rough machining cuts taken on aluminum bronze gear teeth.
C. Design Quality Good mechanical locking of bronze to steel hub by slots located in steel hub.

D. Manufacturing Method & Quality Aluminum-Bronze alloy cast in a permanent mold around steel forged hub. Good quality - As-cast condition. Non-heat treatable alloy.
MICROSTRUCTURE: Very good typical structure showing single phase alpha

6444 - MACRO SECTION OF WORM WHEEL TAKEN FROM THE TURRET DRIVE
